5 April 2022
Ref: 1165-Rev B

Re: Geotechnical Assessment Report
Proposed Residential Subdivision
Chain-O-Ponds & Northern Roads
Mulgoa NSW

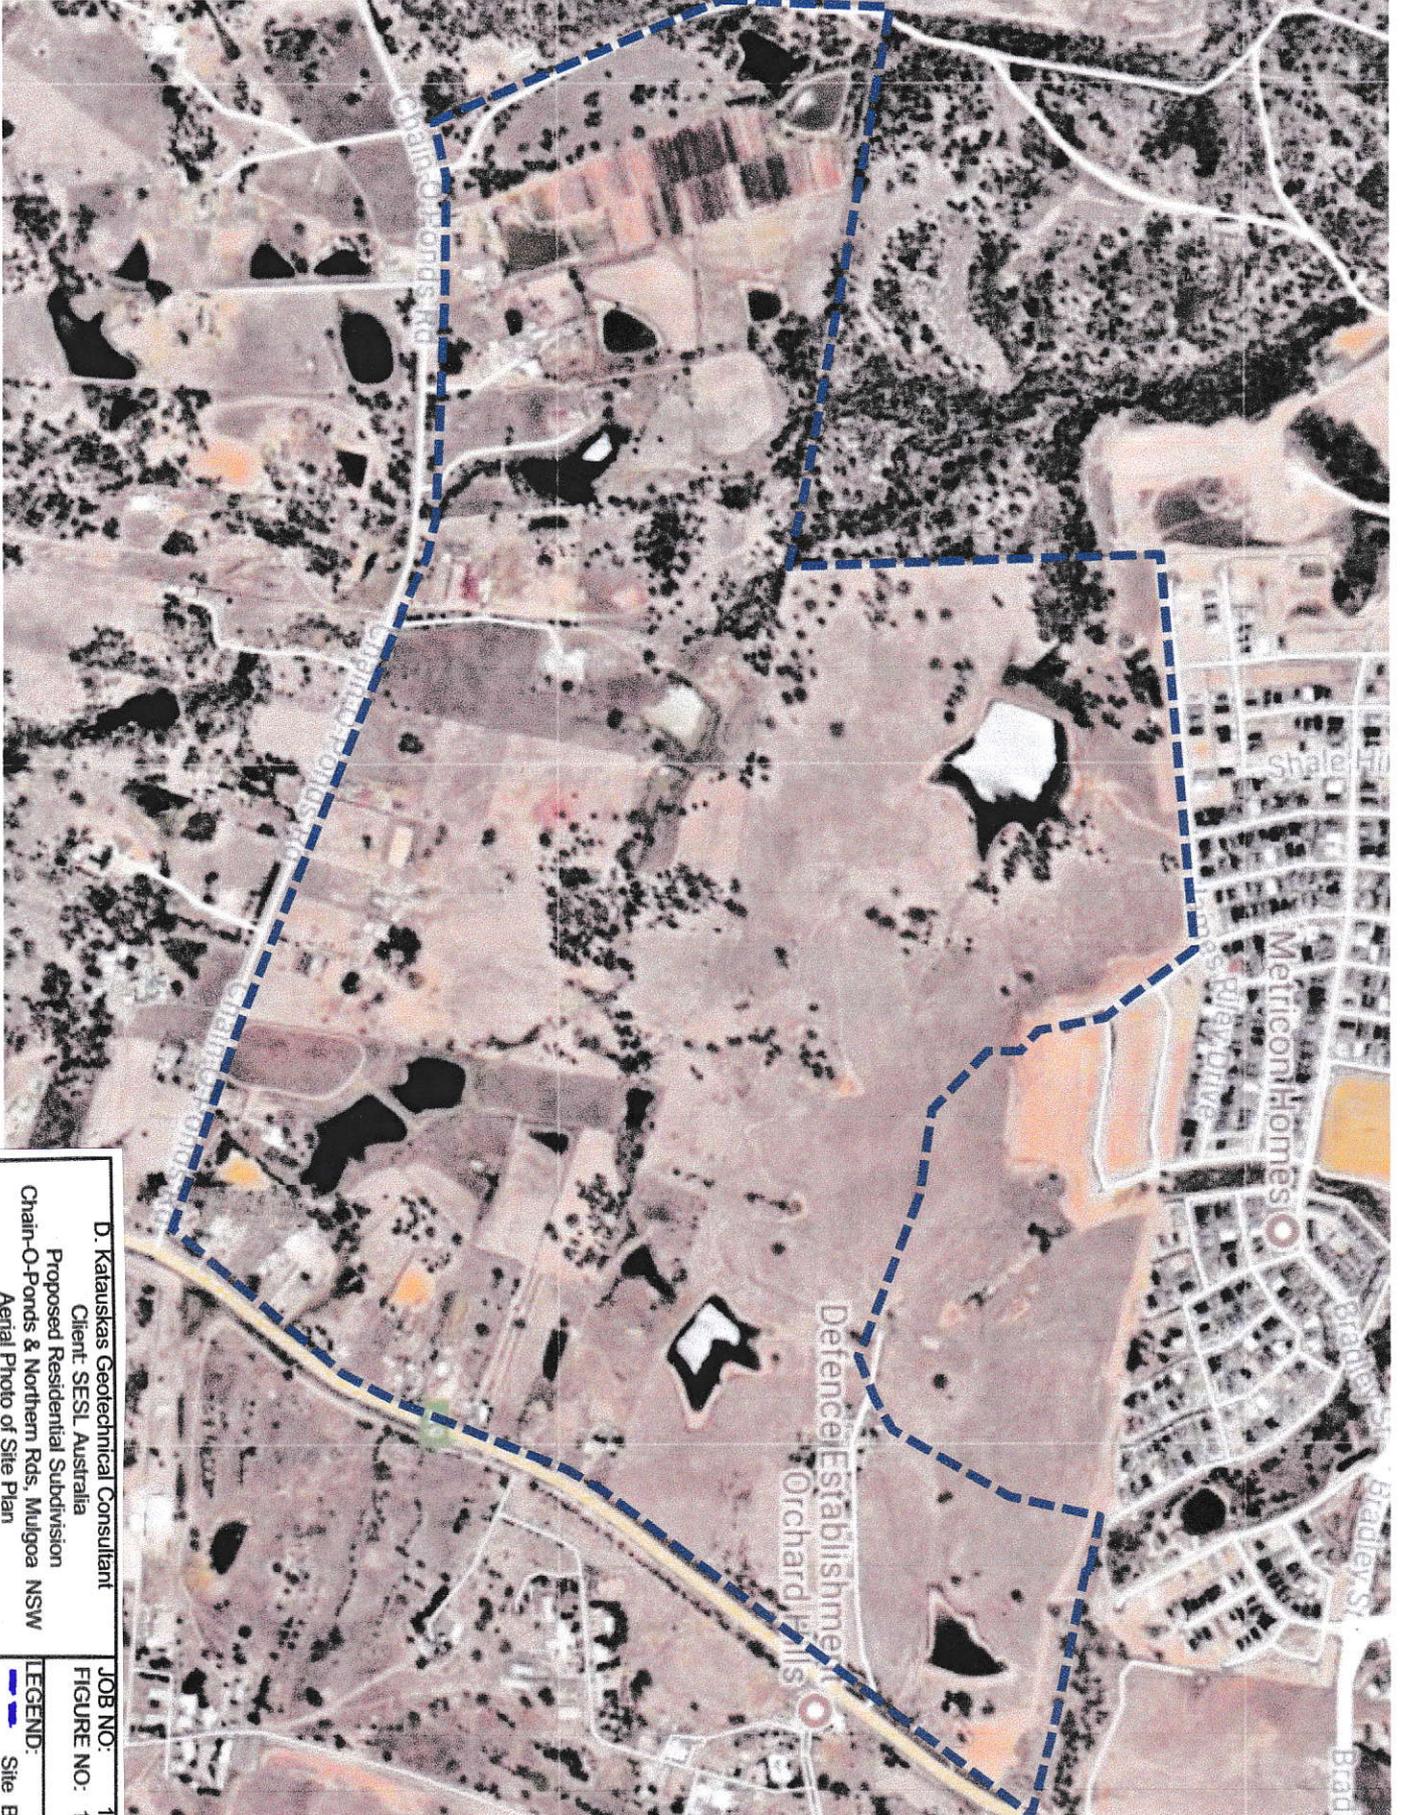
D. Katalauskas Geotechnical Consultant	
Client: SESL Australia	
Proposed Residential Subdivision	
Chain-O-Ponds & Northern Rds, Murrumbidgee NSW	
Aerial Photo of Site Plan	
JOB NO:	1165
FIGURE NO:	1
LEGEND:

The farm dam locations can be seen on the aerial photo image of the site; Figure 1, and may also be identified from the ground contour plan presented on Figure 2.
