Stage 1 Preliminary Site Investigation

221-227 and 289-311 Luddenham Road,
Orchard Hill, NSW, 2748

Prepared for HB+B Property Pty Ltd
1/07/2020

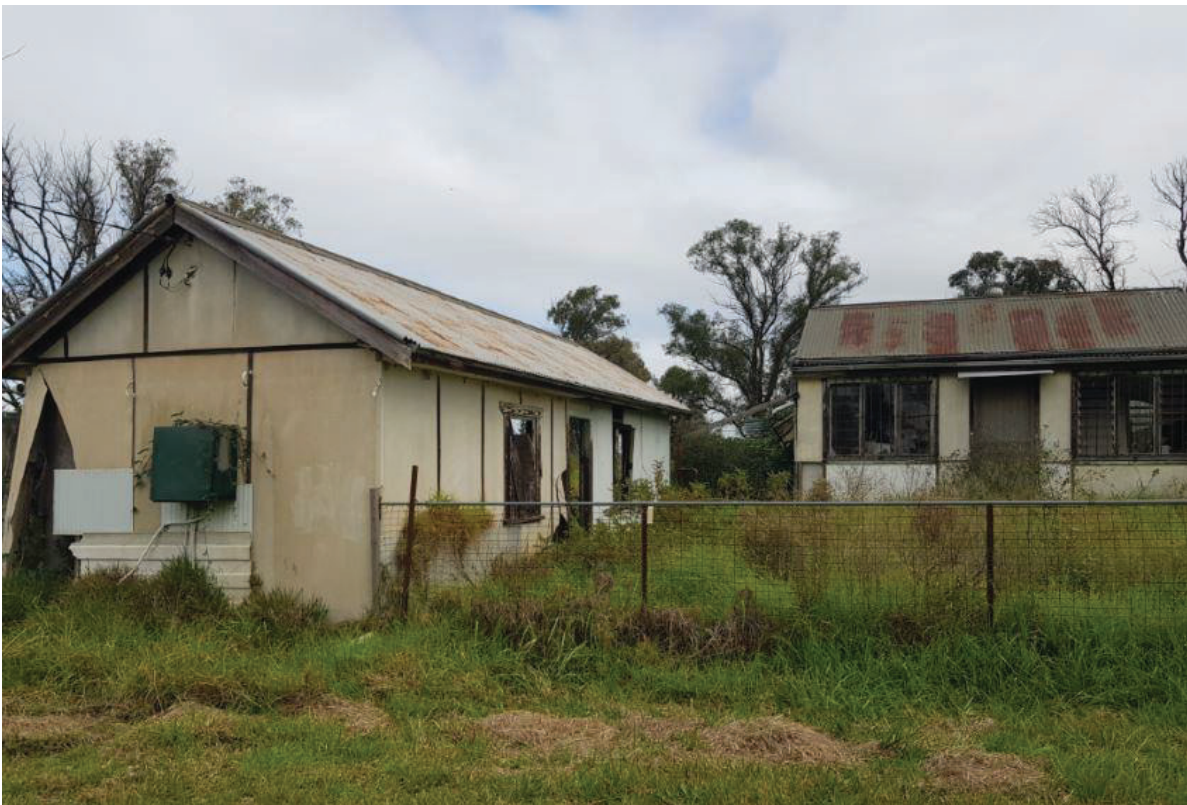
Image 6.2.4 View of the old fibro cottages

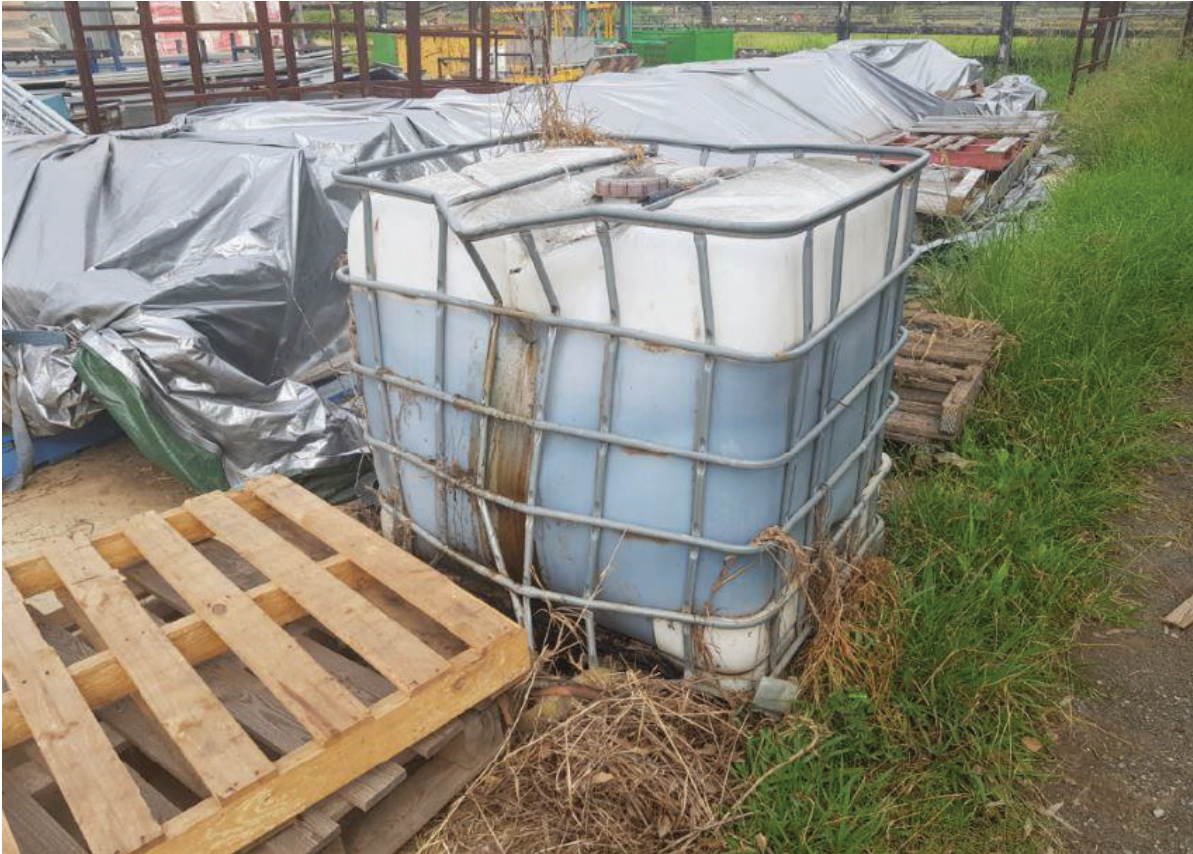
- > a slight valve leak from an intermediate bulk storage container of engine oil, located on a concrete hardstand north of the warehouse.
- > A localised burnt area of ground, most likely used for a bonfire, with residual burnt tree logs and plastics – located approximately 70m east of the residential house in Lot 242 in DP 108899.

Image 6.5.1 View of oil stored in IBC, with slight leak

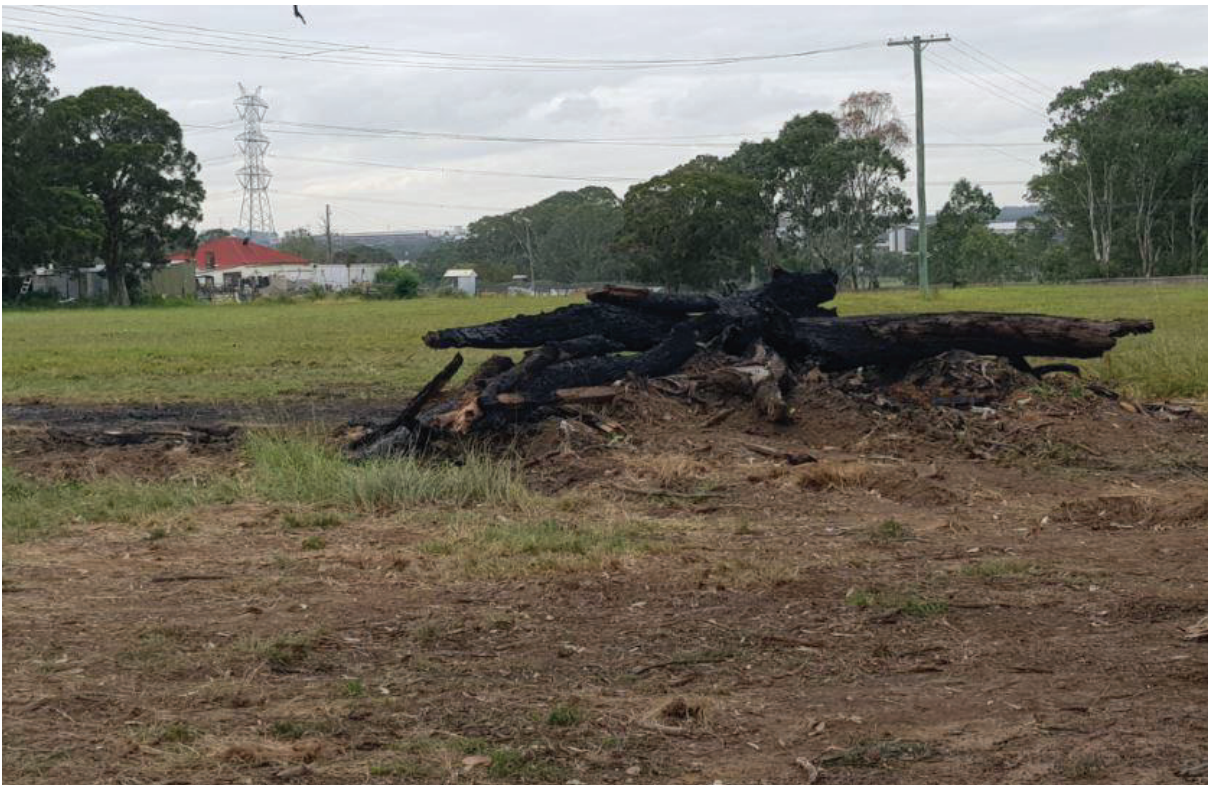
Image 6.5.2 View of bon fire and stained ground

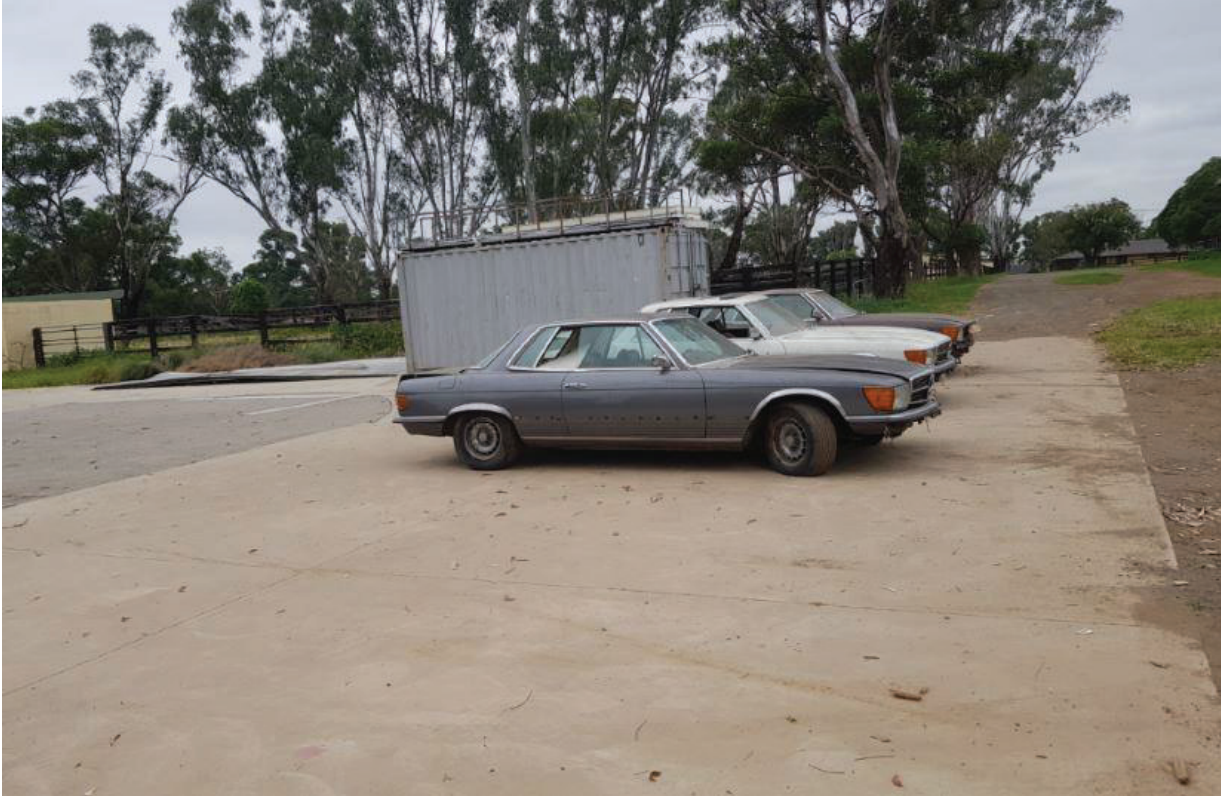
There was no visual evidence of chemical handling and storage during the site walkover, however, anecdotal and visual evidence suggests the owner restores vintage cars and therefore small quantities of chemical storage within the warehouse cannot be dismissed.

Image 6.6.1 View of vehicle wrecks adjacent to warehouse on concrete hardstand

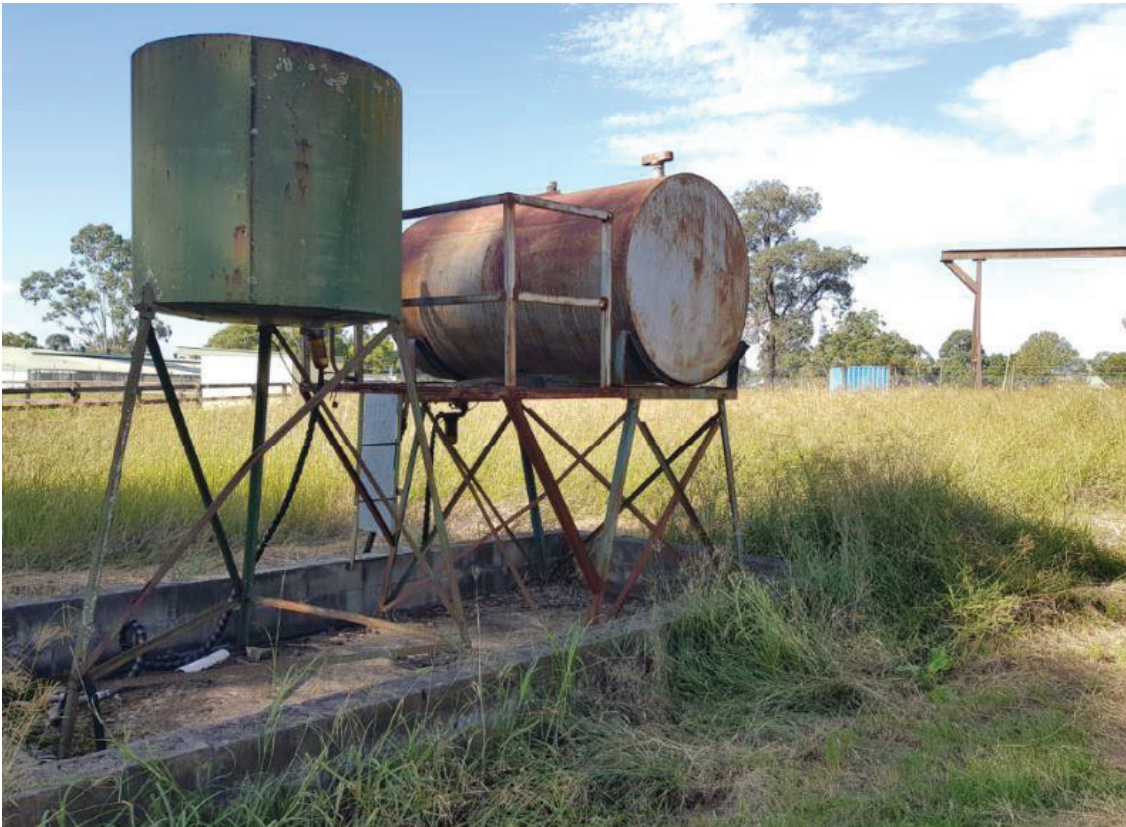
There was visual evidence observed during the walkover, of two aboveground storage tanks (AST) of diesel located together in a concrete bund, approximately 120m south of the warehouse (refer to Figure 2), most likely used for refuelling purposes.

Image 6.7.1 View of above ground diesel tanks

- > The diesel tanks identified onsite appeared empty with little residual diesel remaining. If leaks have occurred into surrounding soils, natural attenuation by micro-organisms and evaporation is likely which may reduce the vapour intrusion potential.

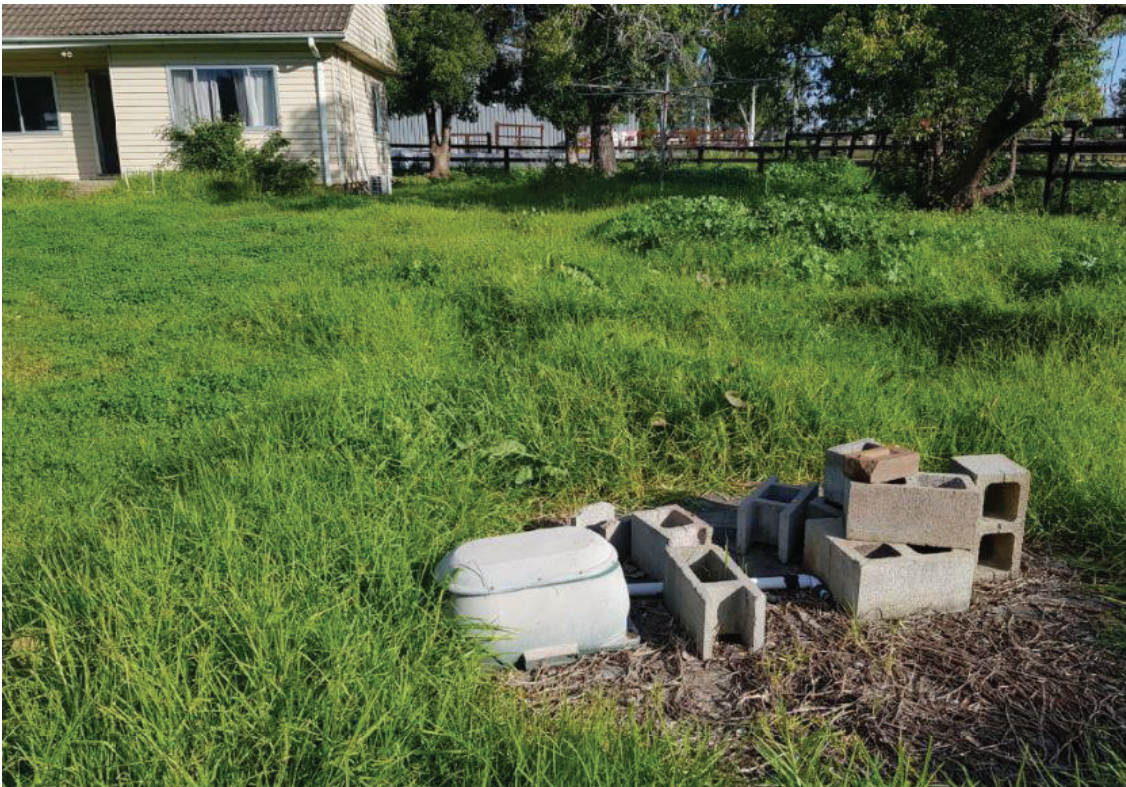
Main sewer lines could not be found at the site and due to the age of the buildings most likely all raw sewage is captured and treated onsite in septic tanks. The site also contains two other residential tenancies, therefore, it is likely additional underground septic tanks are located onsite.

Image 6.7.2 View of potential underground septic tank adjacent to the cabin

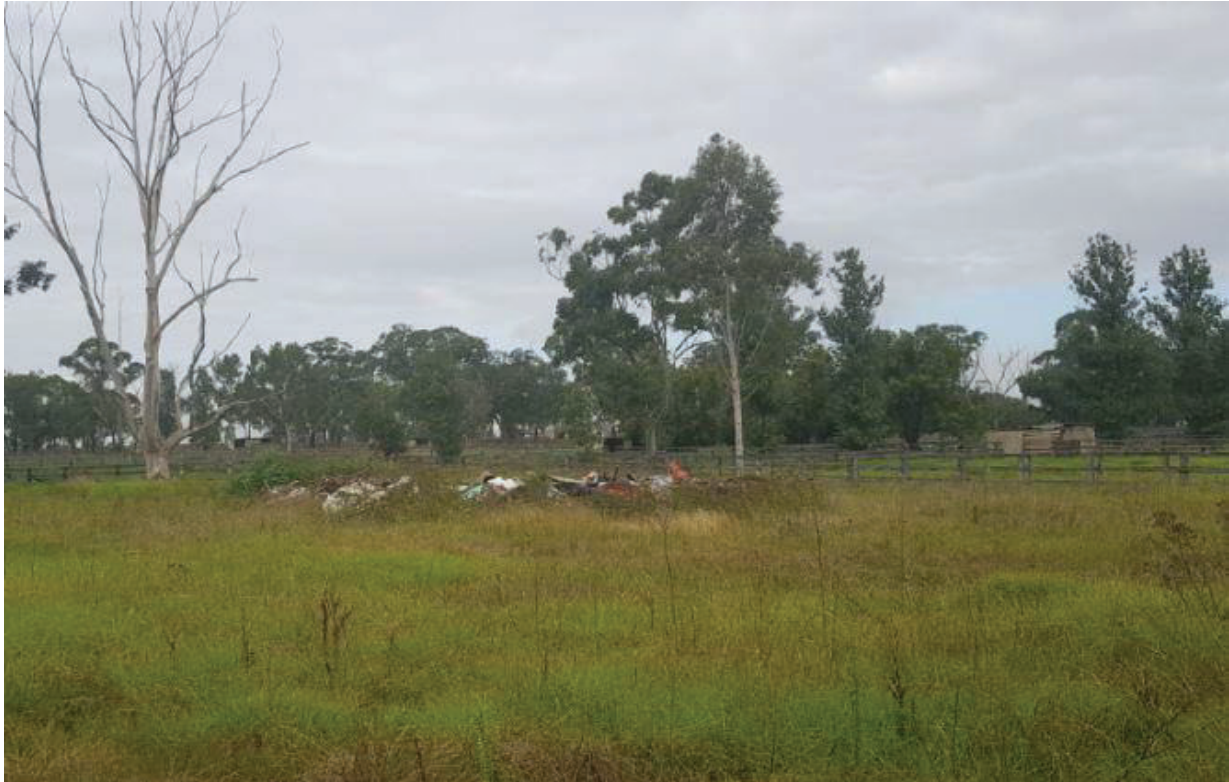
Image 6.8.1 View of demolition and household waste, west of the warehouse

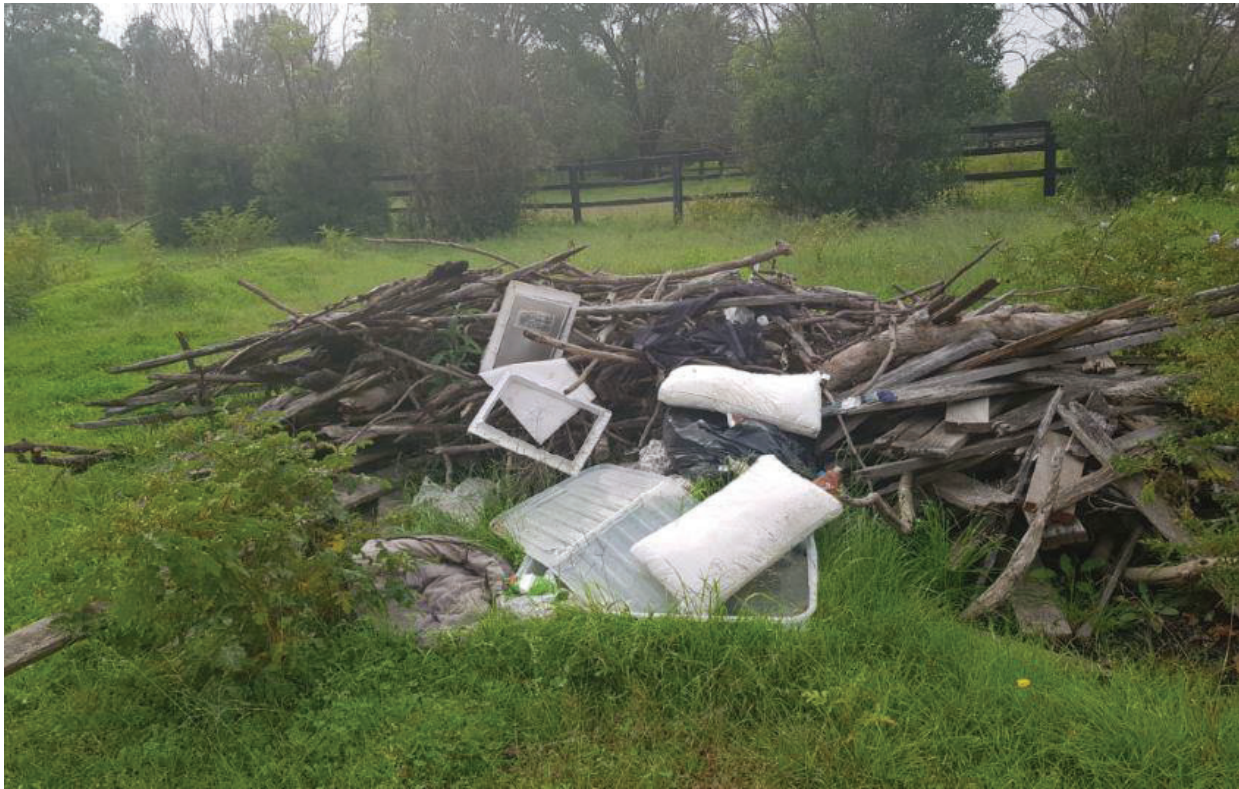
Image 6.8.2 View of household waste and timber north of the cabin

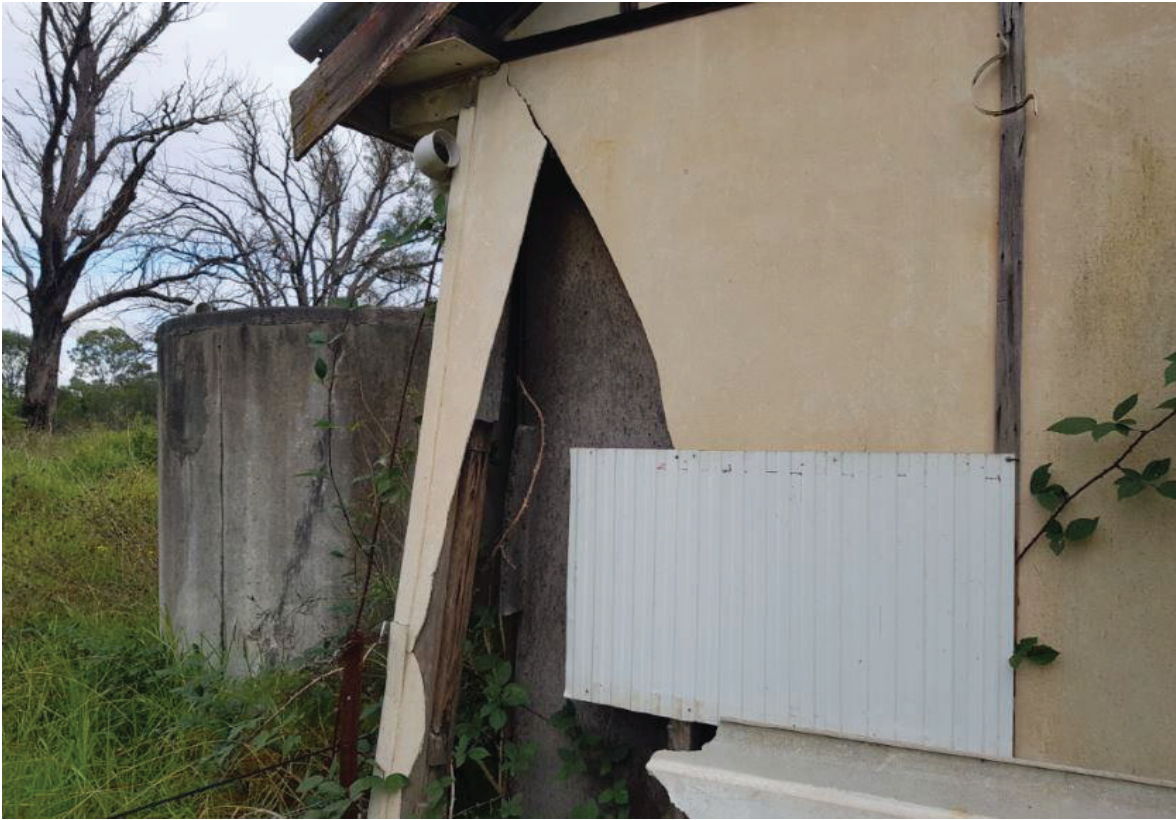
- > Broken fibro walls of the old fibro cottage; and
- > Broken fibro sheeting in a small stack on the surface, located 60m south east of the residential property in Lot 242 in DP 1088991.

Image 6.9.1 View of broken walls of old fibro cottage

Site history information and walkover observations indicate a potential for uncontrolled filling and degradation of ACM in walls of the old fibro cottage. Additional broken ACM fragments were identified, in good condition, collected and stacked nearby the old cottage, which is likely to be sourced from the broken walls of this building. Therefore, presence of asbestos in the form of FA and AF in selected areas of the site cannot be dismissed.

Hazardous building material inspections is beyond the scope of this investigation, hence, further investigation and assessment is warranted, prior to demolition.

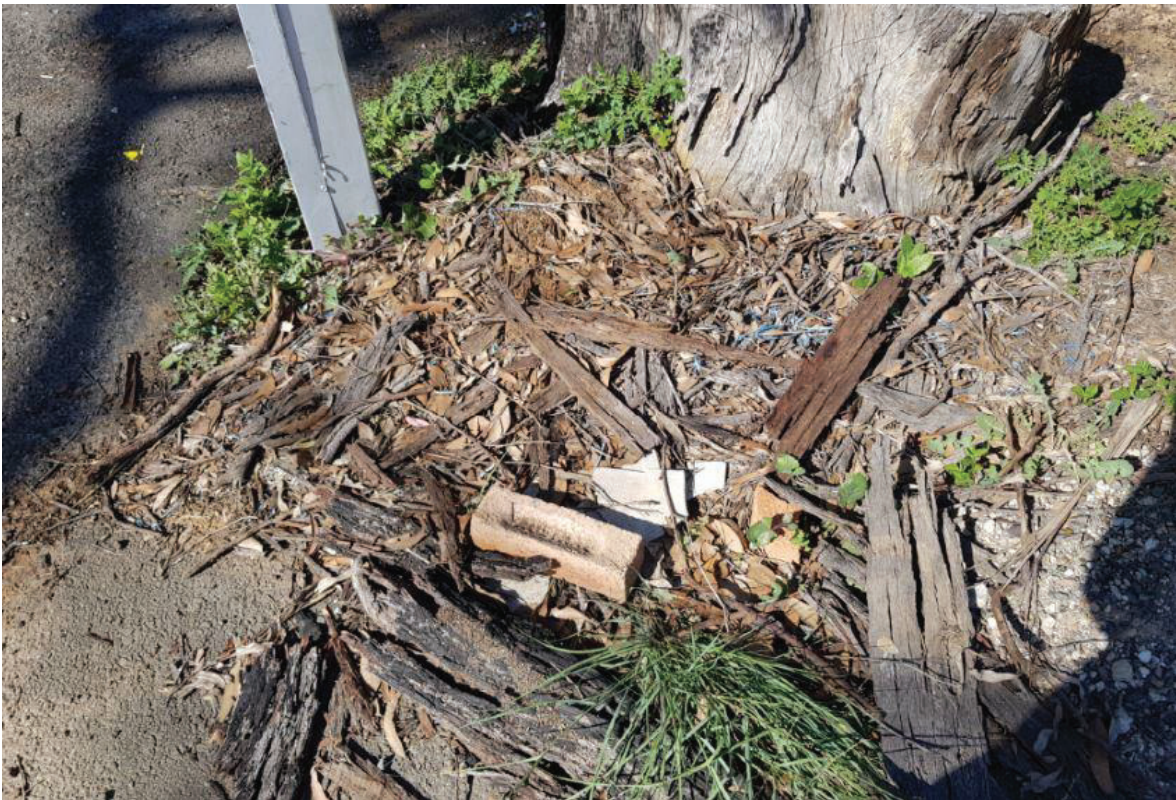
Image 6.9.2 View of potential asbestos containing fibrous cement sheeting

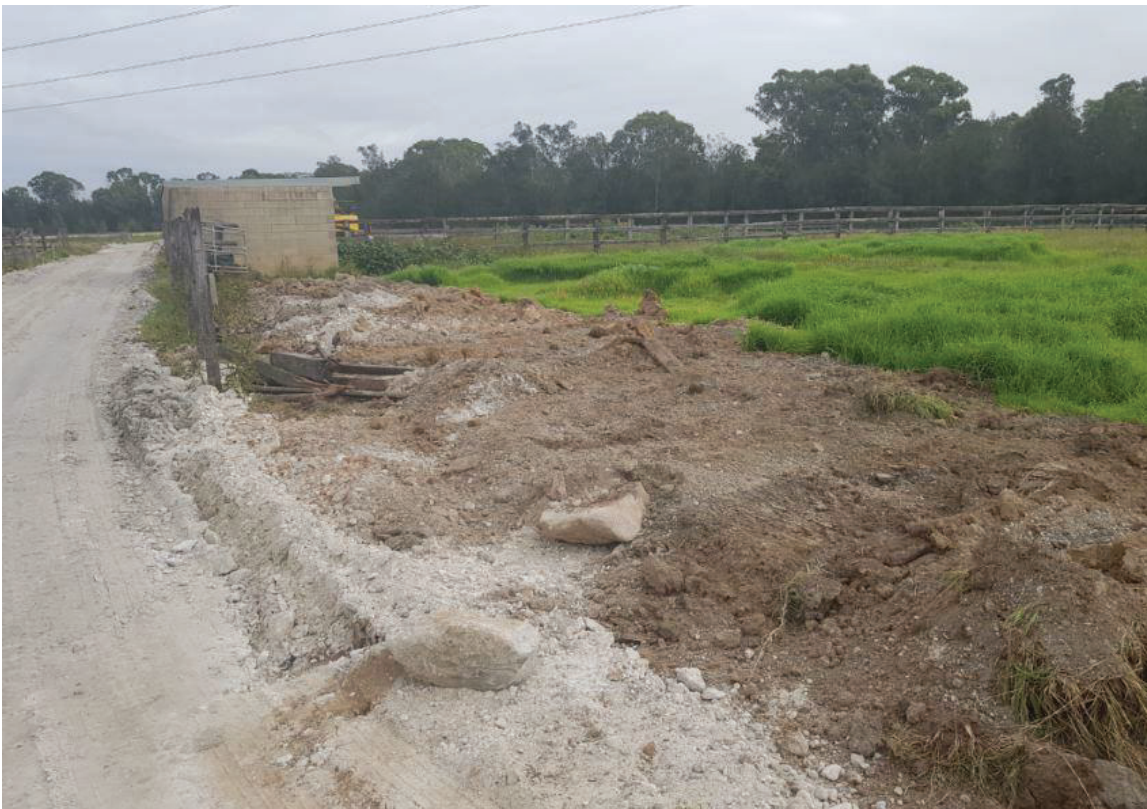
Image 6.10.2 View of disturbed ground, along roadway, northern area of Lot 1 DP1099147

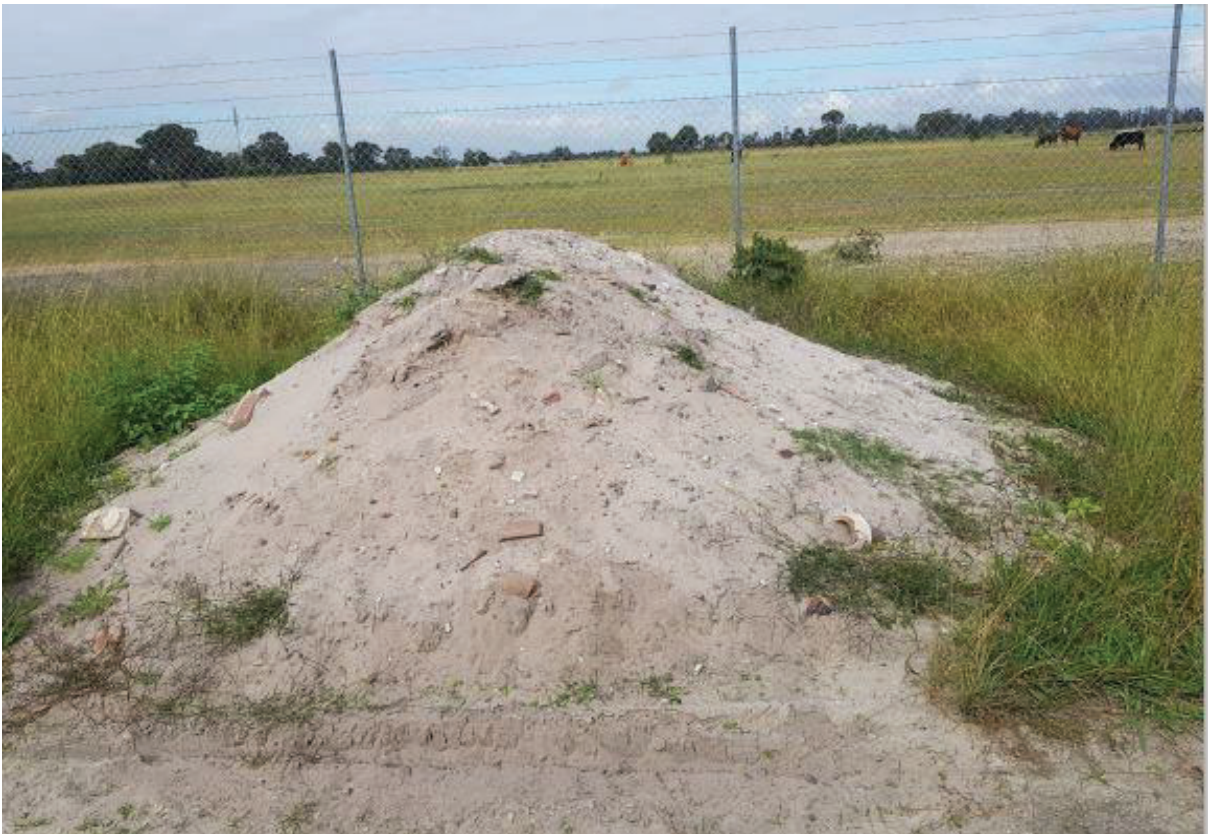
Image 6.10.4 View of sand stockpile with demolition waste inclusions (SP1)

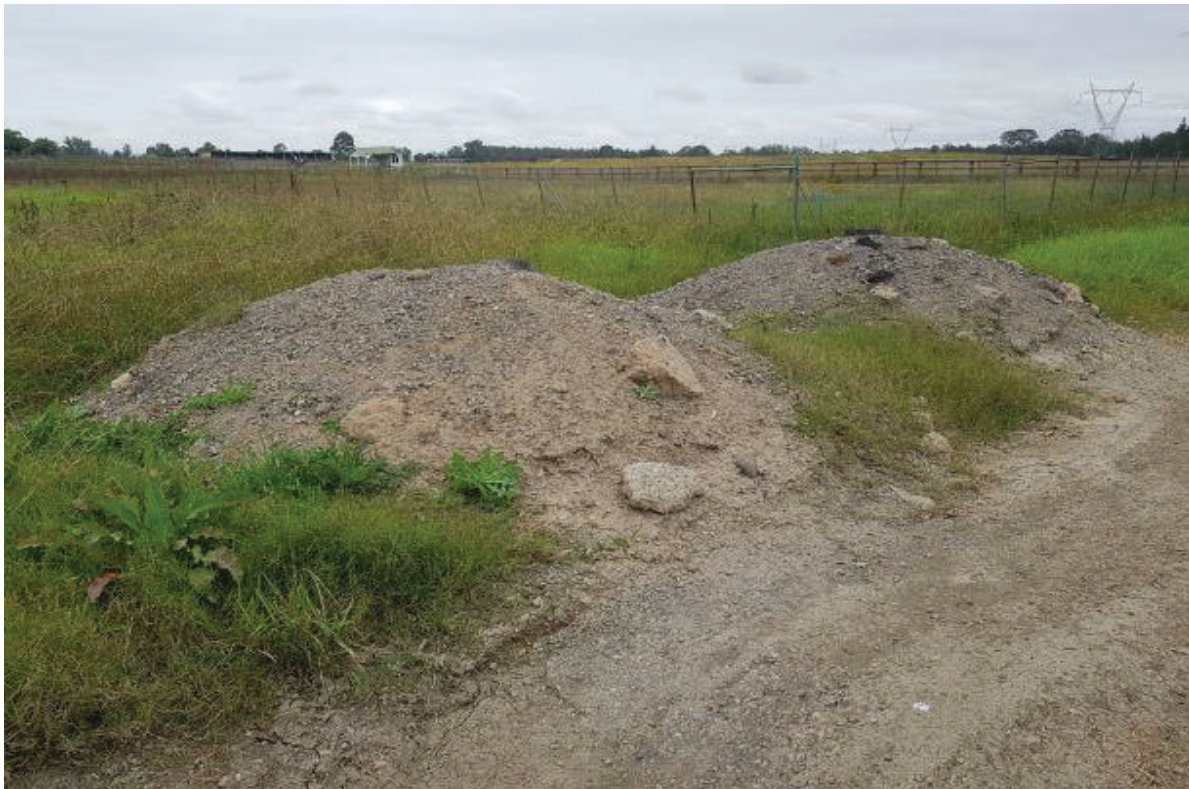
Image 6.10.5 View of stockpiles (SP2 and SP3) containing silt and aggregate with demolition waste inclusions

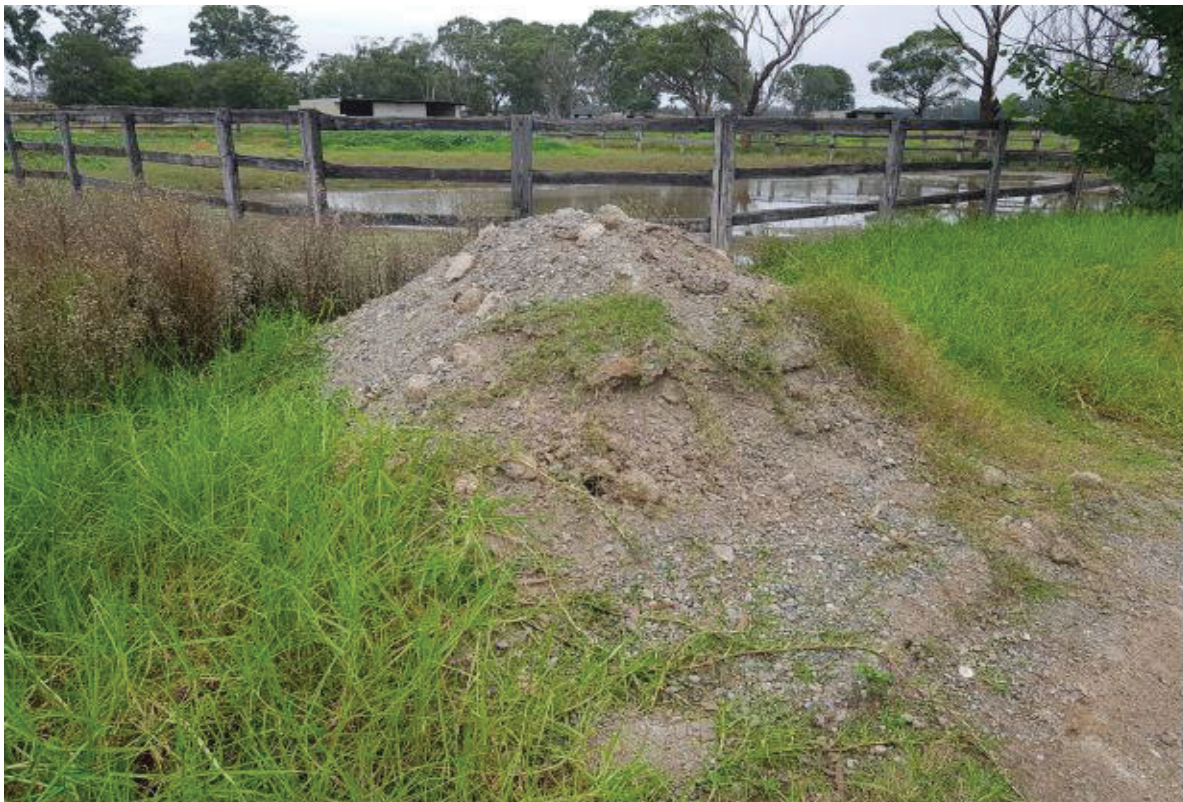
Image 6.10.6 View of stockpile (SP4) containing silt and aggregate with demolition waste inclusions

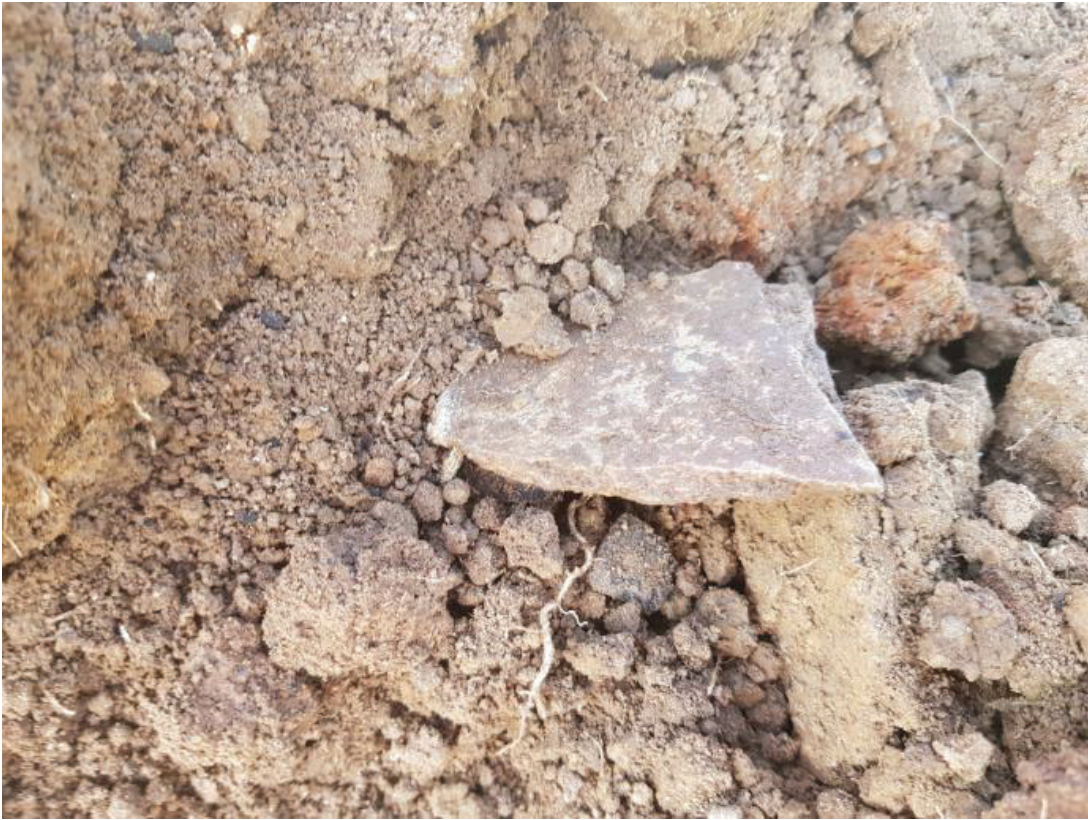
Image 11.1.3 View of ACM encountered at TP21 at 0.3m bgl

- > Undertake a supplementary assessment of the identified asbestos risks, in order to delineate the lateral and vertical extent of the identified asbestos at TP21;
- > A remedial action plan (RAP) should be prepared to include, but not limited to:
 - Remediation methodology;
 - an unexpected find protocol for potential unidentified asbestos contamination or additional contamination found during earthworks;
 - supplementary validation of building footprints post-demolition;
 - validation inspections of footprints of locations which were identified as an aesthetic risk; and
 - Import protocol which will validate material to be imported and guide material tracking.
