Geotechnical Investigation

Proposed Warehouse Development 221-227, 289-317 Luddenham Road Orchard Hills NSW 2748

5017200153-AR1

Prepared for HB+B Property 10/06/2020

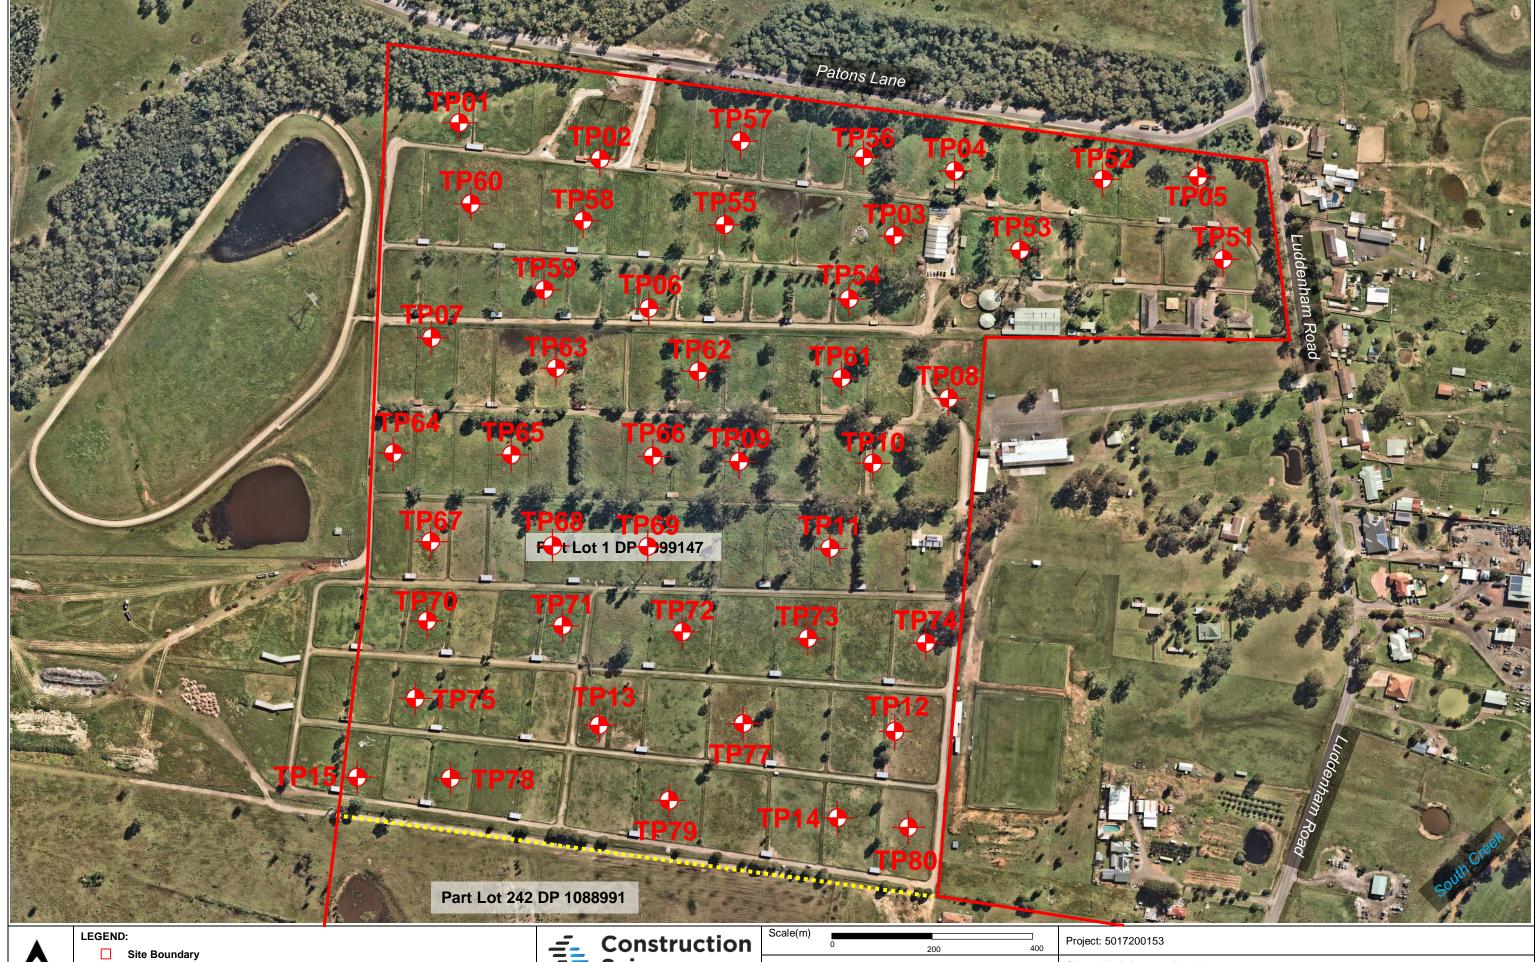
The state of the s				
1	Scale(m) 200 400	Project: 5017200153			
	Date: 4 th May 2020 to 8 th May 2020	Client: HB+B Property Pty Ltd			
	Drawn By: Nicholas Leong	Location: Part Lot 1 in DP 1099147 Address: 221-227 and 289-311 Luddenham Road, Orchard Hills NSW 2745			
	Drawing No: 5017200153-A-1	Sheet: APPROXIMATE TEST PIT LOCATIONS 1 of 2

The subsurface conditions found in the test pits TP1-TP79 are summarised in Table 1 below. Reference should be made to test pit logs included in Appendix B.

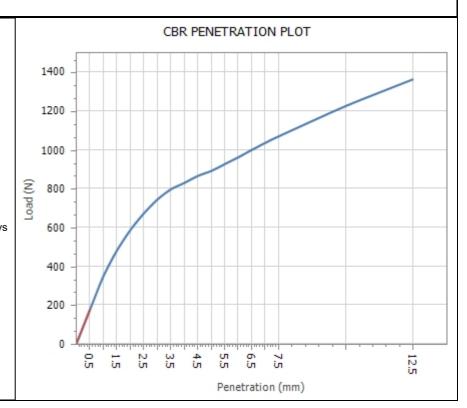
Material Description Red Silty Clay

Maximum Dry Density (t/m³):	1.55
Optimum Moisture Content (%):	21.0
Field Moisture Content (%):	17.8
Sample Percent Oversize (%)	1.0
Oversize Included / Excluded	Excluded
Target Density Ratio (%):	100
Target Moisture Ratio (%):	100
Placement Dry Density (t/m³):	1.55
Placement Dry Density Ratio (%):	100.0
Placement Moisture Content (%):	20.7
Placement Moisture Ratio (%):	99.5
Test Condition / Soaking Period:	Soaked / 4 Day
CBR Surcharge (kg)	9.0
Dry Density After Soak (t/m³):	1.51
Total Curing Time (hrs)	n/a
Liquid Limit Method	n/a
Moisture (top 30mm) After Soak (%)	28.3
Moisture (remainder) After Soak (%)	25.0
CBR Swell (%):	3.0
Minimum CBR Specification (%):	-
CBR Value @ 2.5mm (%):	5

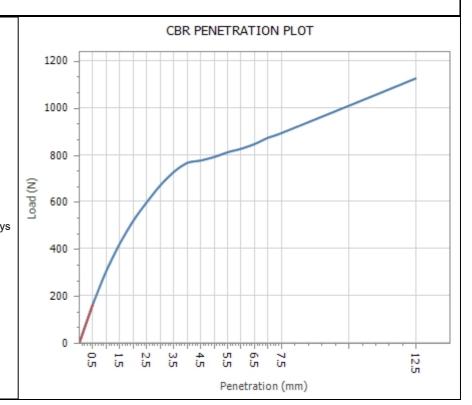
Material Description Brown Silty Gravelly Clay

Maximum Dry Density (t/m³):	1.54
Optimum Moisture Content (%):	22.5
Field Moisture Content (%):	19.4
Sample Percent Oversize (%)	2.0
Oversize Included / Excluded	Excluded
Target Density Ratio (%):	100
Target Moisture Ratio (%):	100
Placement Dry Density (t/m³):	1.53
Placement Dry Density Ratio (%):	99.5
Placement Moisture Content (%):	22.5
Placement Moisture Ratio (%):	100.0
Test Condition / Soaking Period:	Soaked / 4 Day
CBR Surcharge (kg)	9.0
Dry Density After Soak (t/m³):	1.47
Total Curing Time (hrs)	n/a
Liquid Limit Method	n/a
Moisture (top 30mm) After Soak (%)	37.3
Moisture (remainder) After Soak (%)	32.1
CBR Swell (%):	4.0
Minimum CBR Specification (%):	-
CBR Value @ 2.5mm (%):	4.5
_	•

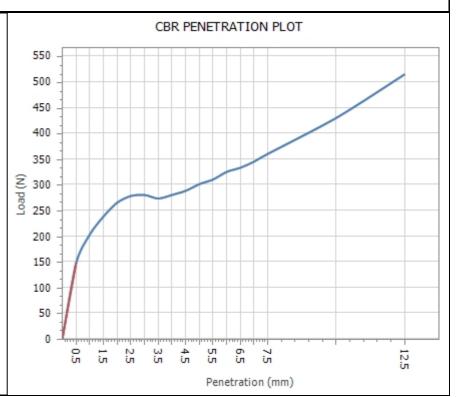
Material Description Brown clay

Maximum Dry Density (t/m³):	1.68
Optimum Moisture Content (%):	16.0
Field Moisture Content (%):	6.8
Sample Percent Oversize (%)	0.0
Oversize Included / Excluded	Excluded
Target Density Ratio (%):	100
Target Moisture Ratio (%):	100
Placement Dry Density (t/m³):	1.68
Placement Dry Density Ratio (%):	100.5
Placement Moisture Content (%):	16.1
Placement Moisture Ratio (%):	99.5
Test Condition / Soaking Period:	Soaked / 4 Days
CBR Surcharge (kg)	9.0
Dry Density After Soak (t/m³):	1.60
Total Curing Time (hrs)	25
Liquid Limit Method	Estimation
Moisture (top 30mm) After Soak (%)	29.1
Moisture (remainder) After Soak (%)	22.2
CBR Swell (%):	5.0
Minimum CBR Specification (%):	-
CBR Value @ 2.5mm (%):	2.0

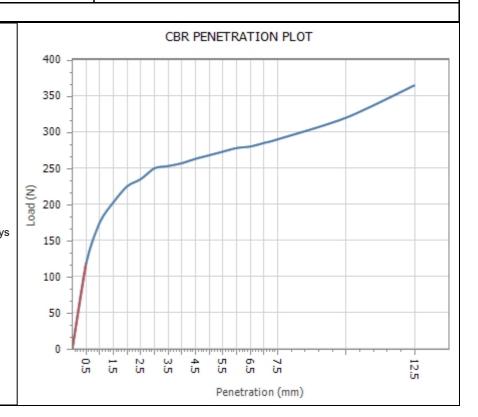
Material Description Red Silty Clay

Maximum Dry Density (t/m³):	1.63
Optimum Moisture Content (%):	20.0
Field Moisture Content (%):	17.3
Sample Percent Oversize (%)	0.0
Oversize Included / Excluded	Excluded
Target Density Ratio (%):	100
Target Moisture Ratio (%):	100
Placement Dry Density (t/m³):	1.63
Placement Dry Density Ratio (%):	100.0
Placement Moisture Content (%):	20.3
Placement Moisture Ratio (%):	100.5
Test Condition / Soaking Period:	Soaked / 4 Day
CBR Surcharge (kg)	9.0
Dry Density After Soak (t/m³):	1.55
Total Curing Time (hrs)	n/a
Liquid Limit Method	n/a
Moisture (top 30mm) After Soak (%)	33.7
Moisture (remainder) After Soak (%)	24.1
CBR Swell (%):	5.5
Minimum CBR Specification (%):	-
CBR Value @ 2.5mm (%):	2.0

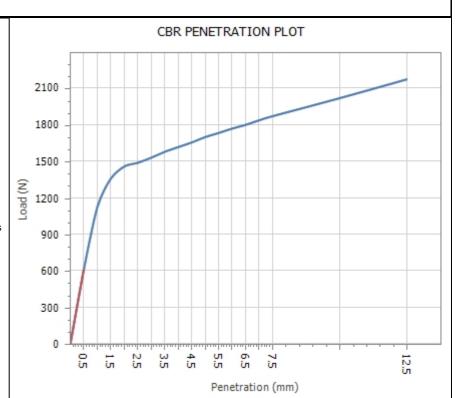
Material Description Red clay

Maximum Dry Density (t/m³):	1.53
Optimum Moisture Content (%):	27.5
Field Moisture Content (%):	21.0
Sample Percent Oversize (%)	0.0
Oversize Included / Excluded	Excluded
Target Density Ratio (%):	100
Target Moisture Ratio (%):	100
Placement Dry Density (t/m³):	1.53
Placement Dry Density Ratio (%):	100.0
Placement Moisture Content (%):	27.5
Placement Moisture Ratio (%):	100.5
Test Condition / Soaking Period:	Soaked / 4 Days
CBR Surcharge (kg)	9.0
Dry Density After Soak (t/m³):	1.53
Total Curing Time (hrs)	24
Liquid Limit Method	Estimation
Moisture (top 30mm) After Soak (%)	-
Moisture (remainder) After Soak (%)	-
CBR Swell (%):	0.5

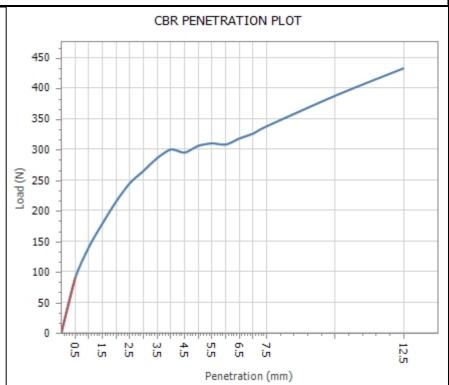
Material Description Brown Silty Slightly Gravelly Clay

CBR Value @ 2.5mm (%):	2.0
Minimum CBR Specification (%):	-
CBR Swell (%):	5.0
Moisture (remainder) After Soak (%)	23.2
Moisture (top 30mm) After Soak (%)	30.4
Liquid Limit Method	n/a
Total Curing Time (hrs)	n/a
Dry Density After Soak (t/m³):	1.57
CBR Surcharge (kg)	9.0
Test Condition / Soaking Period:	Soaked / 4 Day
Placement Moisture Ratio (%):	99.5
Placement Moisture Content (%):	15.7
Placement Dry Density Ratio (%):	100.5
Placement Dry Density (t/m³):	1.65
Target Moisture Ratio (%):	100
Target Density Ratio (%):	100
Oversize Included / Excluded	Excluded
Sample Percent Oversize (%)	0.0
Field Moisture Content (%):	14.2
Optimum Moisture Content (%):	16.0
Maximum Dry Density (t/m³):	1.65

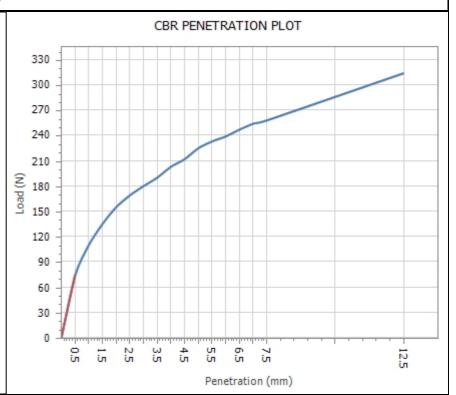
Material Description Brown Silty Slightly Gravelly Clay

CBR Value @ 2.5mm (%):	1.5
	1.5
Minimum CBR Specification (%):	_
CBR Swell (%):	5.5
Moisture (remainder) After Soak (%)	29.4
Moisture (top 30mm) After Soak (%)	35.5
Liquid Limit Method	n/a
Total Curing Time (hrs)	n/a
Dry Density After Soak (t/m³):	1.59
CBR Surcharge (kg)	9.0
Test Condition / Soaking Period:	Soaked / 4 Days
Placement Moisture Ratio (%):	100.5
Placement Moisture Content (%):	17.7
Placement Dry Density Ratio (%):	100.5
Placement Dry Density (t/m³):	1.68
Target Moisture Ratio (%):	100
Target Density Ratio (%):	100
Oversize Included / Excluded	Excluded
Sample Percent Oversize (%)	0.0
Field Moisture Content (%):	15.1
Optimum Moisture Content (%):	17.5
Maximum Dry Density (t/m³):	1.67

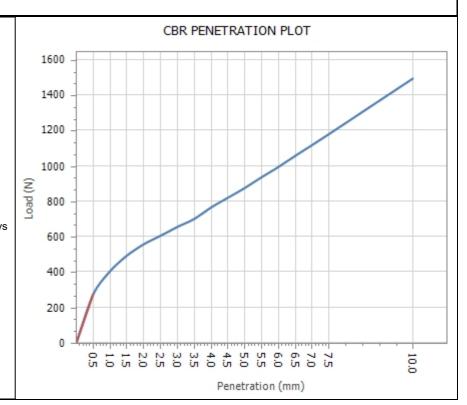
Material Description Brown Silty Garvelly Clay

, , ,	, - ,
Maximum Dry Density (t/m³):	1.71
Optimum Moisture Content (%):	16.0
Field Moisture Content (%):	13.5
Sample Percent Oversize (%)	1.0
Oversize Included / Excluded	Excluded
Target Density Ratio (%):	100
Target Moisture Ratio (%):	100
Placement Dry Density (t/m³):	1.71
Placement Dry Density Ratio (%):	100.0
Placement Moisture Content (%):	15.9
Placement Moisture Ratio (%):	100.0
Test Condition / Soaking Period:	Soaked / 4 Day
CBR Surcharge (kg)	9.0
Dry Density After Soak (t/m³):	1.65
Total Curing Time (hrs)	n/a
Liquid Limit Method	n/a
Moisture (top 30mm) After Soak (%)	24.4
Moisture (remainder) After Soak (%)	21.0
CBR Swell (%):	3.5
Minimum CBR Specification (%):	-
CBR Value @ 2.5mm (%):	4.5

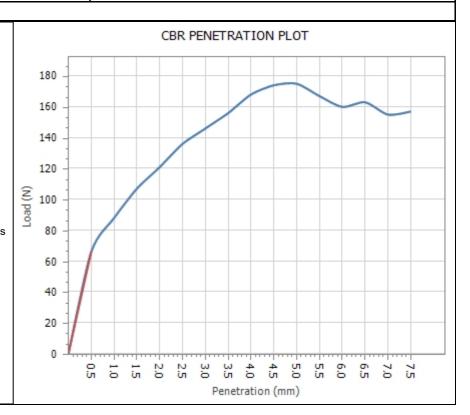
Brown Silty Gravelly Clay Material Description

, ,
Maximum Dry Density (t/m³):	1.57
Optimum Moisture Content (%):	15.5
Field Moisture Content (%):	11.6
Sample Percent Oversize (%)	2.0
Oversize Included / Excluded	Excluded
Target Density Ratio (%):	100
Target Moisture Ratio (%):	100
Placement Dry Density (t/m³):	1.57
Placement Dry Density Ratio (%):	100.5
Placement Moisture Content (%):	15.3
Placement Moisture Ratio (%):	99.5
Test Condition / Soaking Period:	Soaked / 4 Days
CBR Surcharge (kg)	9.0
Dry Density After Soak (t/m³):	1.45
Total Curing Time (hrs)	n/a
Liquid Limit Method	n/a
Moisture (top 30mm) After Soak (%)	37.5
Moisture (remainder) After Soak (%)	31.5
CBR Swell (%):	8.5
Minimum CBR Specification (%):	-
CBR Value @ 2.5mm (%):	1.0

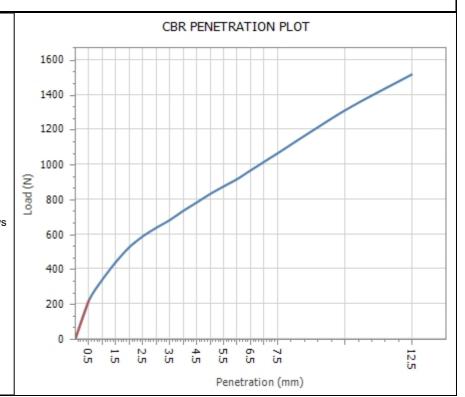
Material Description Brown Silty Gravelly Clay

' '	<u> </u>
Maximum Dry Density (t/m³):	1.66
Optimum Moisture Content (%):	16.5
Field Moisture Content (%):	15.5
Sample Percent Oversize (%)	1.0
Oversize Included / Excluded	Excluded
Target Density Ratio (%):	100
Target Moisture Ratio (%):	100
Placement Dry Density (t/m³):	1.66
Placement Dry Density Ratio (%):	100.0
Placement Moisture Content (%):	16.3
Placement Moisture Ratio (%):	100.0
Test Condition / Soaking Period:	Soaked / 4 Day
CBR Surcharge (kg)	9.0
Dry Density After Soak (t/m³):	1.60
Total Curing Time (hrs)	n/a
Liquid Limit Method	n/a
Moisture (top 30mm) After Soak (%)	26.5
Moisture (remainder) After Soak (%)	20.3
CBR Swell (%):	3.5
Minimum CBR Specification (%):	-
CBR Value @ 2.5mm (%):	4.5
